METALLOGRAPHIC AND FRACTOGRAPHIC EXAMINATION

OF 7079 ALUMINUM ALLOY TEST SPECIMENS

THE BOEING COMPANY

**Prepared under Contract No. NAS 1-6474
by
THE BOEING COMPANY
Renton, Washington
for
NATIONAL AERONAUTICS AND SPACE ADMINISTRATION**

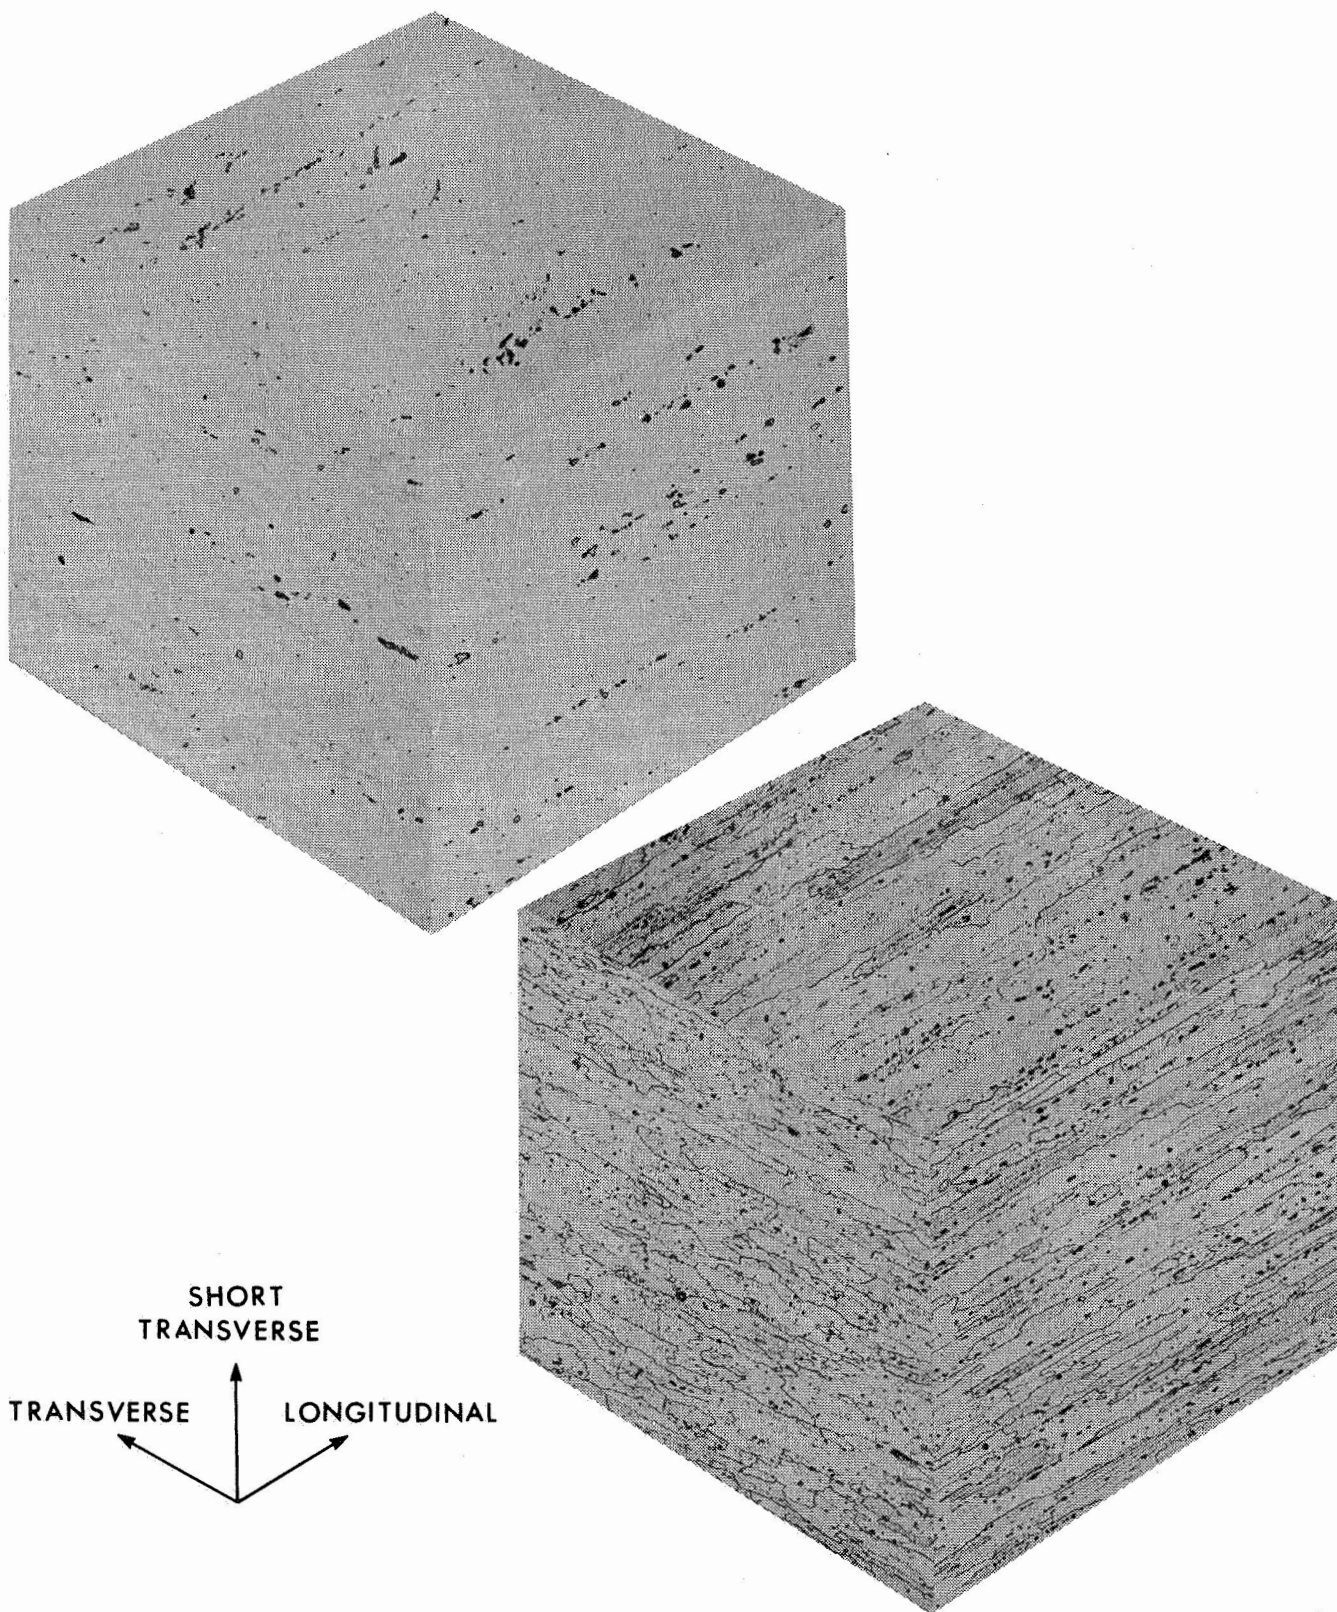
Figure 4. Light and normally etched microstructures of 0.630-inch-thick material in the underaged condition near the plate edge (Magnification 86.5X)

Microstructure of the 0.630-inch-thick material (figures 4 and 5) varied through the thickness. The section taken near the surface shows a higher degree of recrystallization than the midthickness section. The heavily etched streaks in the short transverse plane of the midthickness section are bands where only the polygonization stage of recrystallization has been achieved. In thick material it is difficult to produce uniform deformation through the thickness. In this case, deformation at midthickness was insufficient to cause complete recrystallization. This unrecrystallized material would be expected to have fracture properties somewhat different from the surrounding recrystallized material. By comparing figure 5 with figures 1, 2, and 3, it can be seen that the grain size in the rolling plane is substantially larger for the thicker material at both locations. The degree of recrystallization was less for the thicker material even at the surface where the degree of deformation was greatest.

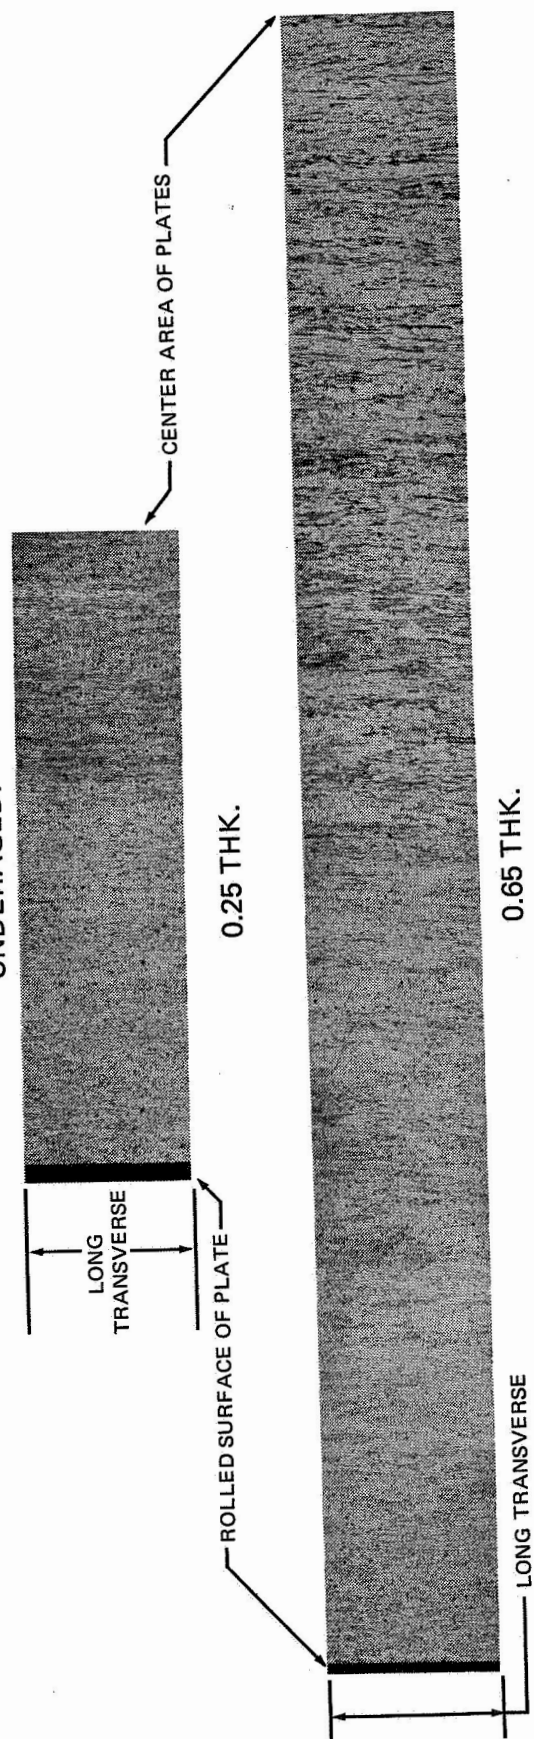
Figure 6. Microstructure as a function of thickness in 0.250 and 0.630-inch-thick material
(Magnification 27X)

The exact significance of the difference in microstructure between the thickest material and the three thinner gages cannot be assessed. However in those tests reported in NASA CR-996 where the mechanical properties of the thickest material did not follow the apparent thickness trends, this microstructural variation must be considered in analyzing the results. A through-the-thickness composite comparing the microstructure of the 0.25-inch and 0.63-inch material as a function of thickness is shown in figure 6.

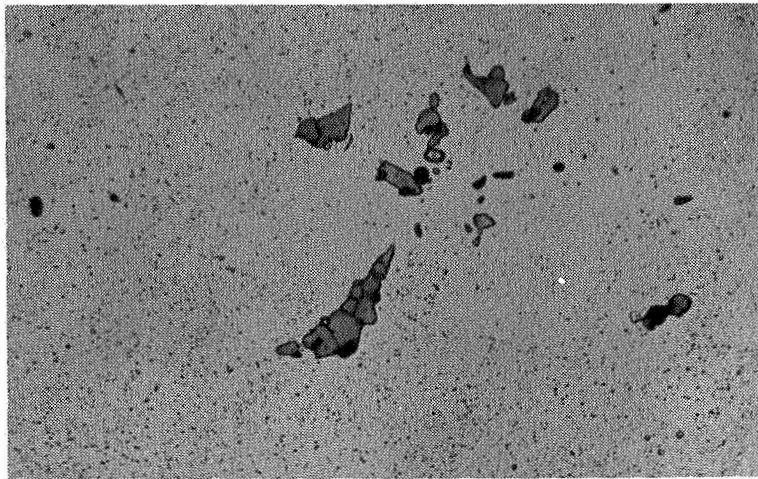
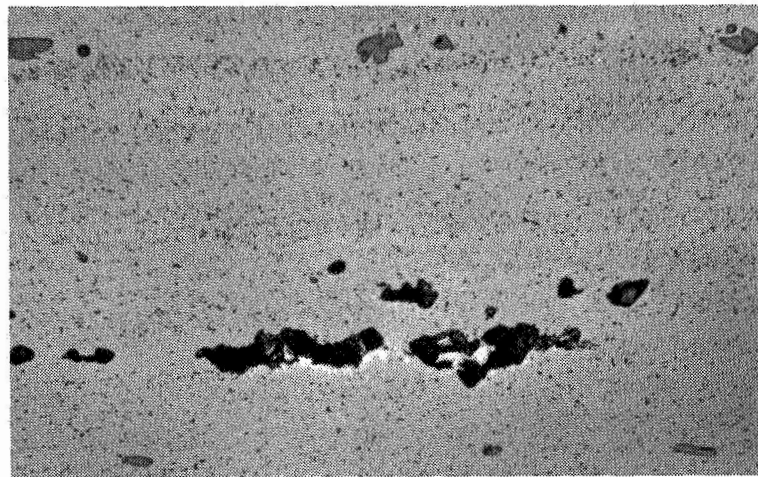
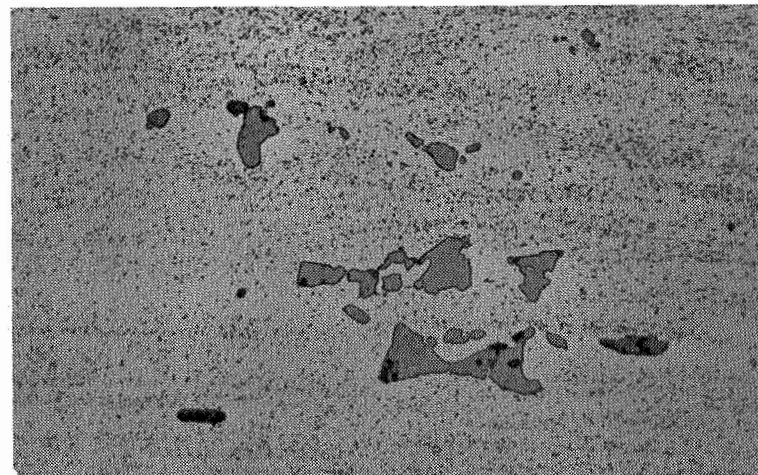
Figure 12. Large intermetallics observed in the 0.500-inch-thick underaged material (Magnification 1000X)

Figure 12 shows the intermetallics in high-magnification (1000X) detail. The intermetallics often contain iron and may be of the type Al_7Cu_2Fe . Another large intermetallic observed contains silicon in the form of Mg_2Si . The precipitate-depleted zone associated with the particles can be observed, but is not particularly pronounced. The zone often occurs in a band parallel to the rolling plane. The appearance and occurrence of intermetallics is typical for this type of alloy. Substantial differences in the quantity of intermetallics observed would cause differences in fracture behavior. The occurrence of intermetallics in these alloys is relatively uniform and should not significantly affect the test results.

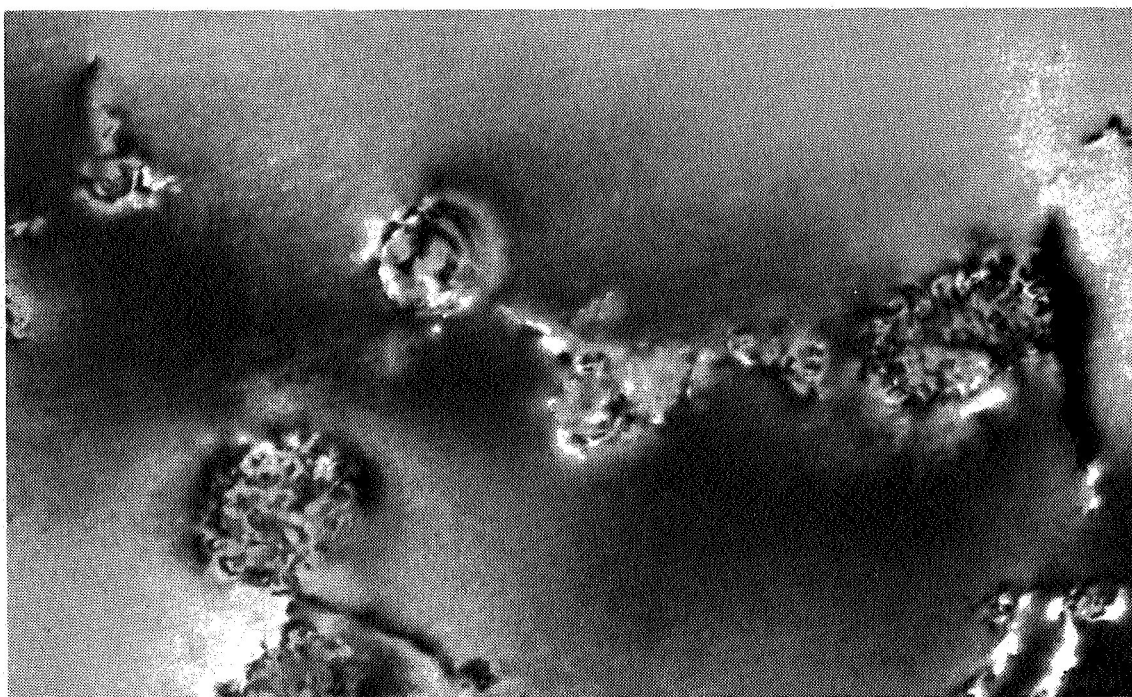
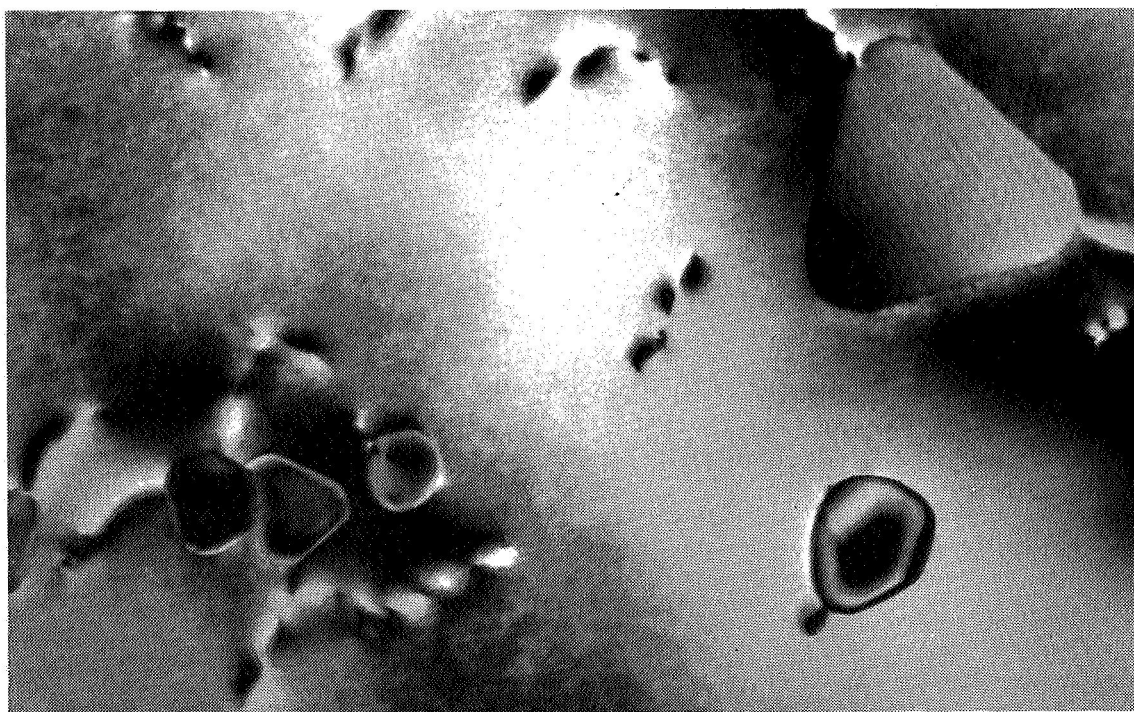
Figure 13. *Transmission electron micrographs (no hardening precipitate can be seen in the structure) (Magnification 150 000X)*

No precipitation was evident in the solution-treated, or solution-treated and room-temperature-aged specimens (figure 13), although some probably occurred during room-temperature aging as a slight increase in hardness was observed. Spherical G.P. zones were observed after a 10-minute age at elevated temperature and subsequent aging coarsened the particles (figures 14 and 15). No tendency for platelet formation was observed, and the spherical shape persisted throughout the aging sequence. No coherency strains were observed, but it is believed that the particles were originally the coherent G.P. zones and, with aging, lost coherency to form the M' and possibly the equilibrium (stable) M phase. Changes in the fracture and fatigue properties as a function of aging would be expected to be associated with the transitions from coherent to semicoherent to incoherent particles. These changes would be associated with the manner in which dislocations overcome obstacles to their motion. While the particles are coherent, passage of a dislocation through the coherent particle is possible. Once a dislocation has passed through the particle, the passage of additional dislocations through the particle on the same plane is favored, giving rise to coplanar arrays of dislocations and possible stress concentrations at pileups along grain boundaries. When the particles become incoherent, dislocation must circumvent the particles, and more tangled dislocation arrays result.

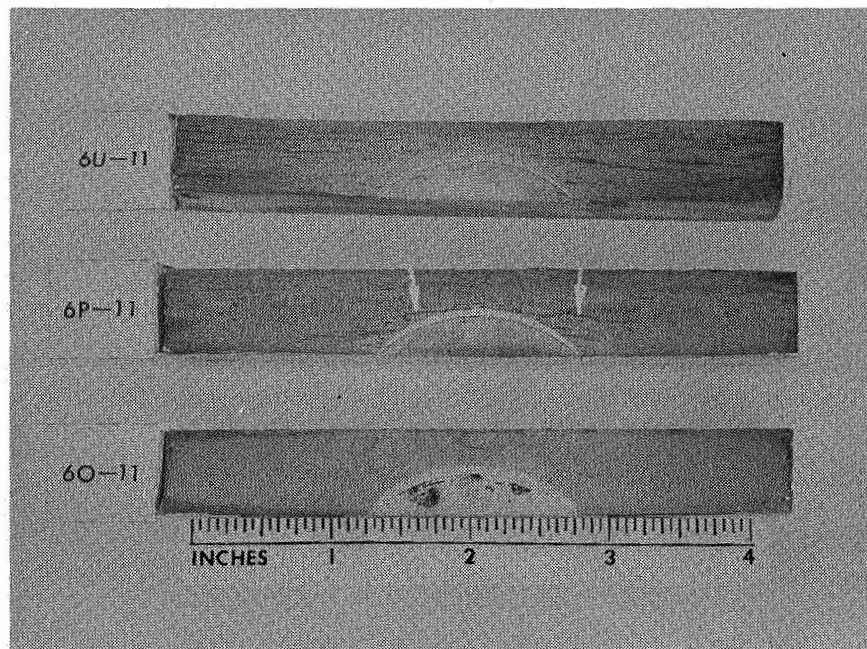
Figure 16. Macroscopic view of surface-flawed fracture-toughness specimens

Results: A photograph of the fractures is shown in figure 16. A tendency for transverse splitting or delamination is apparent in both the underaged and peak-strength specimens. Note particularly the deep transverse split near the tip of the fatigue zone in the peak-strength specimen. By contrast, no delaminations are observed on the overaged specimen.

Conclusions: The high toughness of the peak-aged specimen was due to crack-tip blunting caused by the deep transverse split near the end of the fatigue crack. The serrated appearance of both the underaged and peak-strength specimens indicates some crack-tip blunting because of the delaminations that occurred across each specimen. Since this tendency for delamination is characteristic of the underaged and peak-aged materials, these toughness values are representative for tests in which the crack propagates through the thickness. Scatter in results could be large, with the actual value depending on the amount and the extent of the delamination encountered in each test. There was no evidence that the microstructural variations from surface to midthickness influenced the toughness values.

NOTE: Arrows indicate a transverse split or delamination in specimen 6P-11

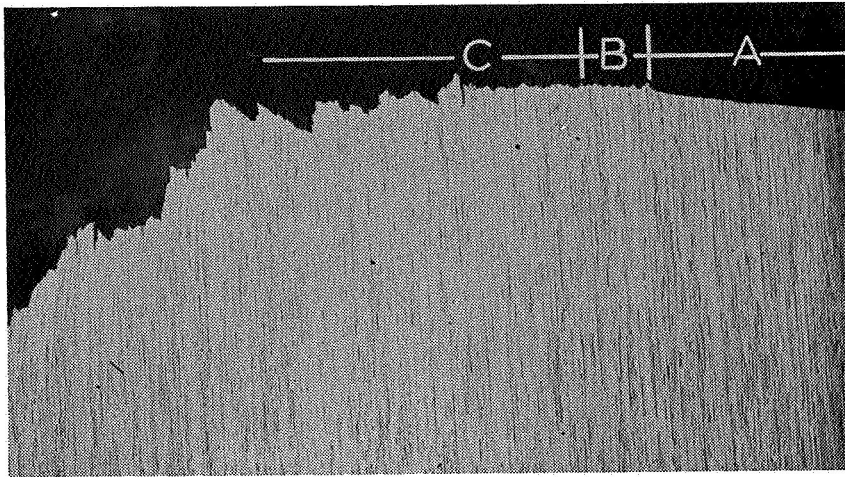
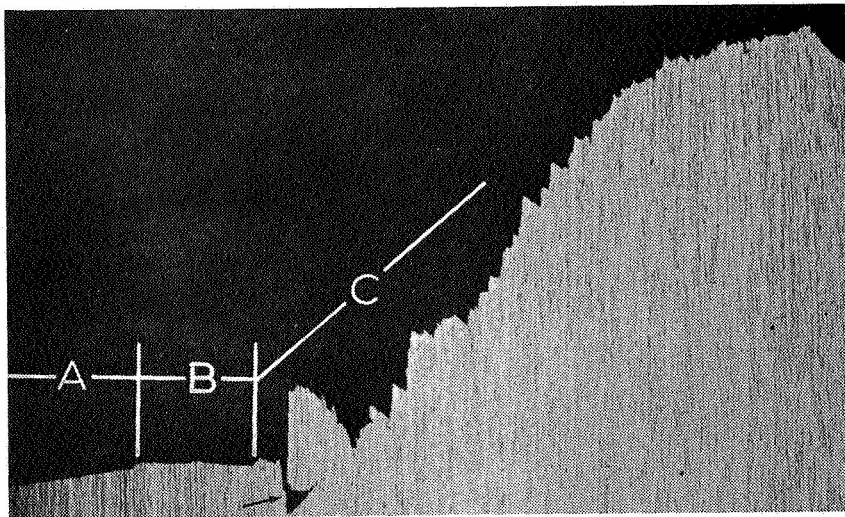
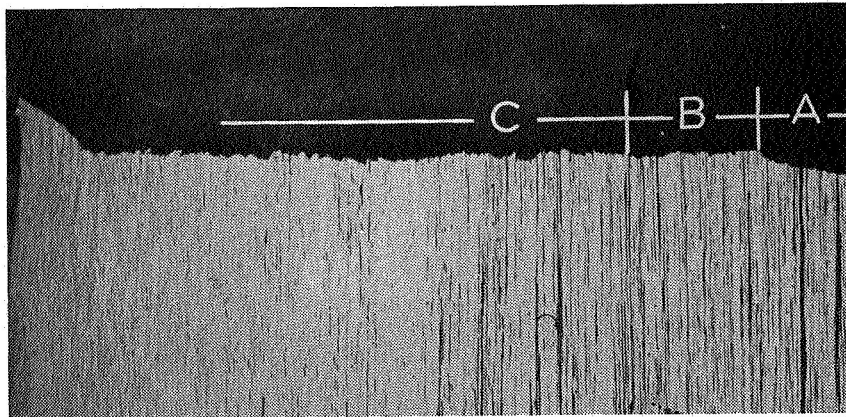
Figure 17. Fracture profiles of surface-flawed fracture-roughness specimens: underaged, peak aged (T6), and overaged heat treatment condition.

Metallurgical sections through the specimen show in profile the machined notch, the fatigue zone, and the rapid-fracture zone, figure 17. The rapid-fracture zone of the underaged and peak-strength specimens is very serrated and lies along a plane approximately 45° to the tensile axis. The deep split in the peak-strength specimen is also readily apparent. The rapid-fracture zone of the overaged specimen, in addition to not showing serrations, is nearly normal to the tensile axis except for a small shear lip at the outside edge. The difference in microstructure through the thickness of this specimen is apparent in these micrographs (particularly the overaged specimen). The fracture features do not appear to correlate with this microstructural variation.

NOTE: A indicates region of machined notch, B indicates region of fatigue pre crack, C indicates region of fast fracture (Magnification 10X)

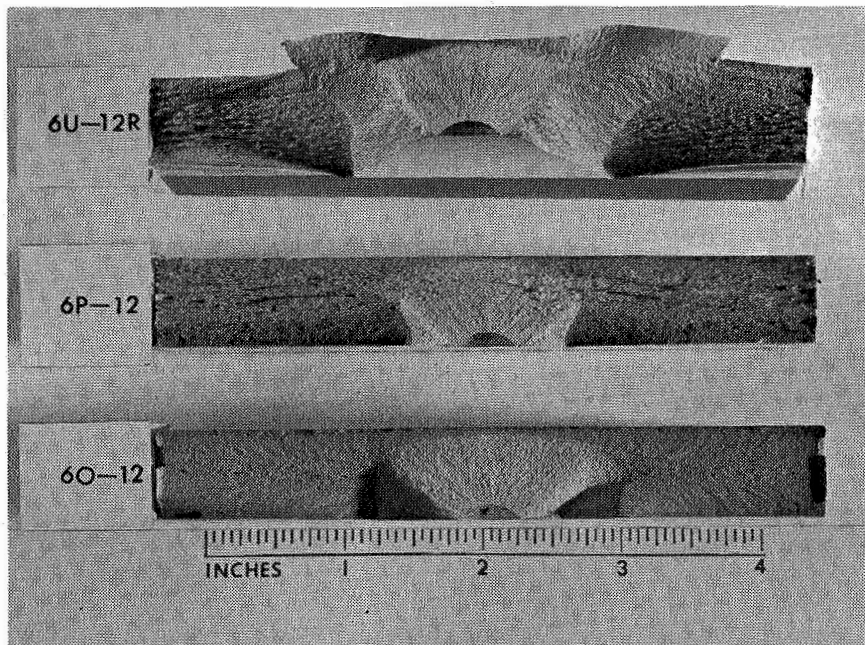
Figure 18. Macroscopic view of surface-flawed fatigue specimens

Results: The specimens are shown in figure 18. The underaged specimen presented an unusual appearance as shown in figure 19. The stress levels chosen for these tests were based upon the K_{IC} values obtained on other surface-flawed specimens. As was shown with specimens 6U-11, 6P-11, and 6O-11, the high apparent toughness of the peak strength material was due to crack-tip blunting at transverse delaminations, but the fatigue crack regions (figure 17) do not show delaminations. For this case, it appears that fatigue-crack-growth rates are more dependent upon K_{II} than on the ratio K_{II}/K_{IC} .

Conclusions: The effect of delamination on toughness was not anticipated when establishing the fatigue-test stress levels. The cycles-to-failure data reflect the influence of the actual cyclic stress value and do not give an indication of behavior under the same K_{II} conditions. In this case, a more meaningful comparison would have been achieved by using the same gross area stress for all three heat-treatment conditions.

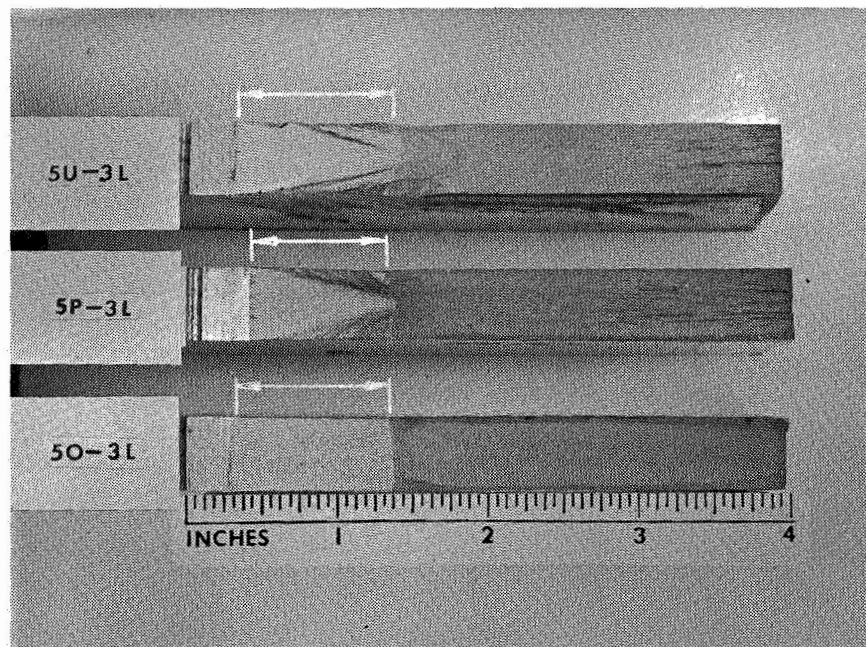
Figure 20. Macroscopic view of 0.500-inch-thick center-notched fatigue panels

Results: A photograph of the fractures is shown in figure 20. The appearance of the fatigue zones was typical for the respective heat-treatment conditions, but the unusual appearance of the fatigue zones on the underaged and peak-aged materials have not been explained. This unusual fracture appearance was characterized by deviations from the general fracture plane. Compare 5U-3L and 5P-3L with 5O-3L in figure 20. These deviations increase with increasing stress intensity level and show some of the features expected in the development of shear lips except for their irregular nature. Overaging appears to provide a more homogeneous material as reflected in the uniform appearance of the fatigue zone of 5O-3L in figure 20.

Conclusions: No metallurgical reason for the toughness anomaly was determined. The unusual fracture appearance of the fatigue zone in the underaged and peak-strength case appears to be related to microstructural inhomogeneties that can be removed by additional aging.

NOTE: Arrows indicate the extent of the fatigue zone

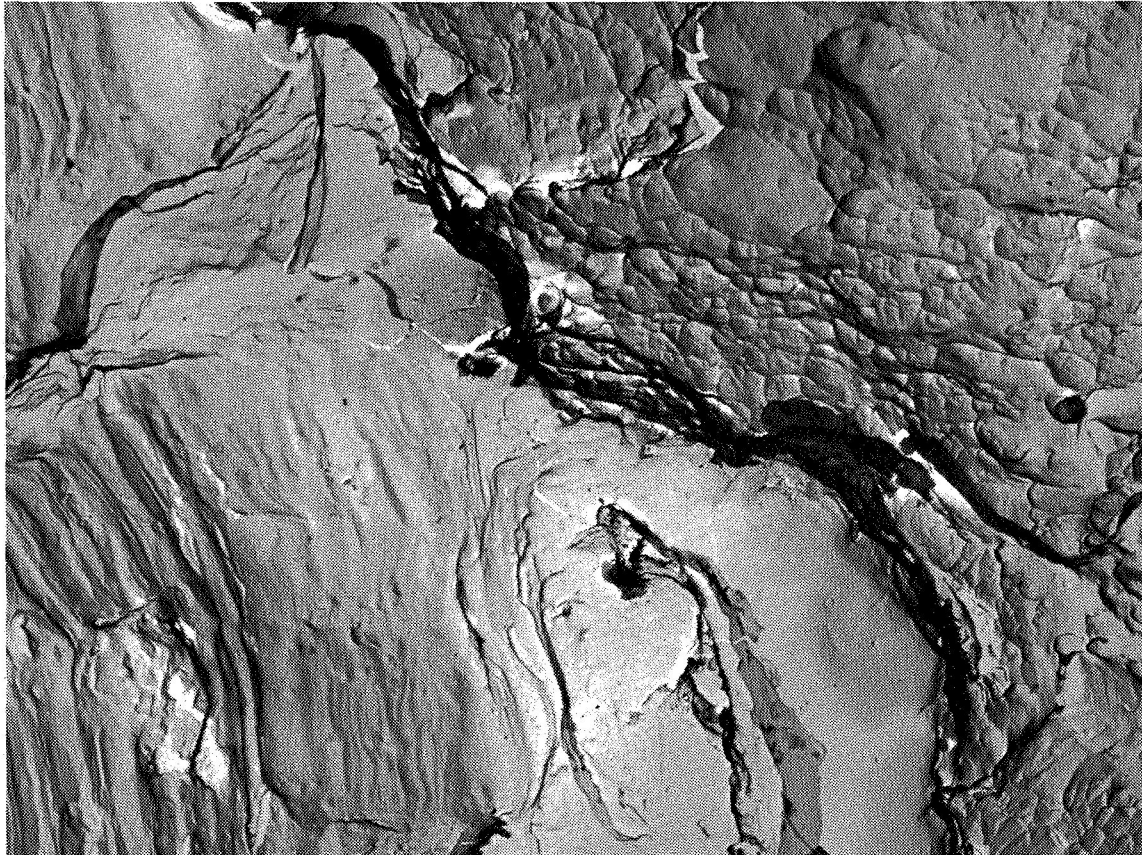
Figure 21. Electron fractograph of the fatigue-to-fast-fracture interface for the underaged specimen (Magnification 3200X)

The fatigue-to-fast-fracture transition was examined on these specimens in each heat-treat condition to determine if a difference could be observed fractographically. No difference was observed between the underaged and overaged materials. This is not surprising, however, as the difference was only about $5\sqrt{\text{ksi}}$ in. Figure 21 (from the underaged specimen) is typical of the interface for both conditions.

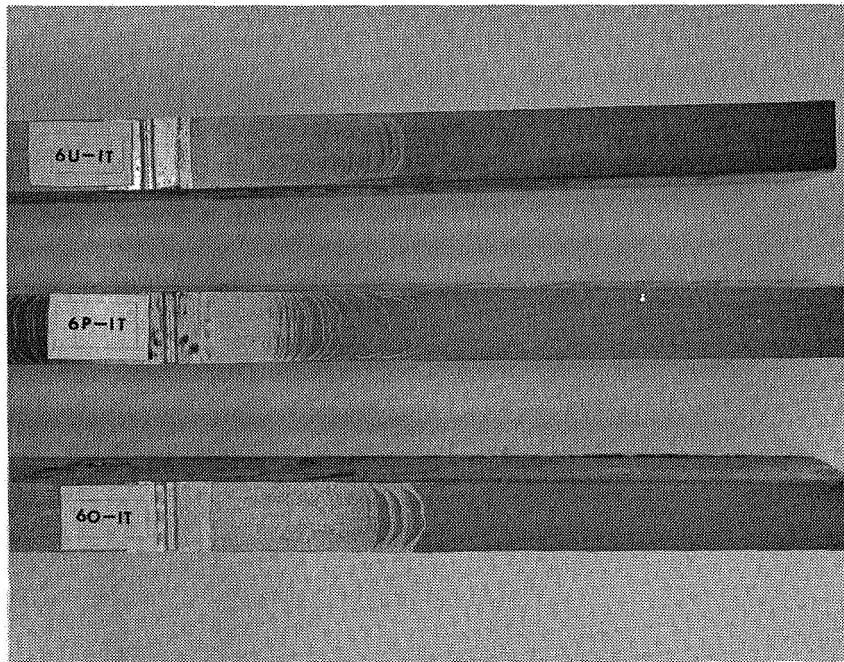
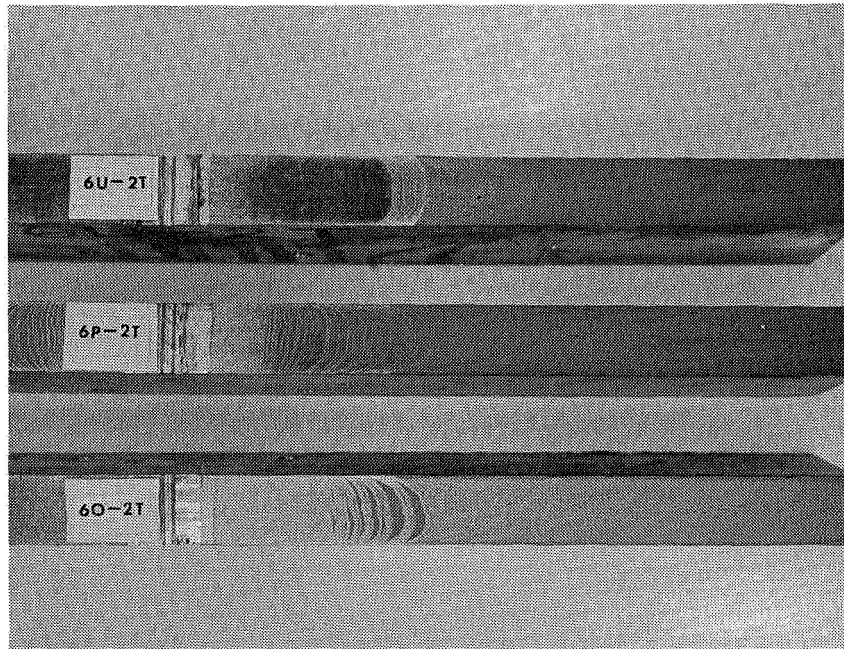
Figure 22. Macroscopic view of 0.63-inch-thick center-notched fatigue specimens

Results: The 0.25-inch-thick specimens were examined at crack lengths (2a) of 0.75 (initiation), 0.85, 1.20, 1.60, 2.00, 3.00, and 3.50 inches (transition from fatigue to fast fracture). The 0.63-inch-thick specimens shown in figure 22 were examined at crack lengths (2a) of 1.0, 1.5, 2.25, and 3.25 inches. A systematic variation in fracture topography is apparent when comparing specimens tested in dry air with specimens tested in distilled water and with the remaining test conditions constant. These variations are illustrated in figures 23, 24, and 25 for the underaged, T6, and overaged conditions respectively. Note that all magnifications are the same and that the crack lengths and stress conditions are identical for each fracture area pictured.

NOTE: Specimens designated -1T and -2T were tested in dry air and distilled water respectively (Magnification approximately 1/2X)

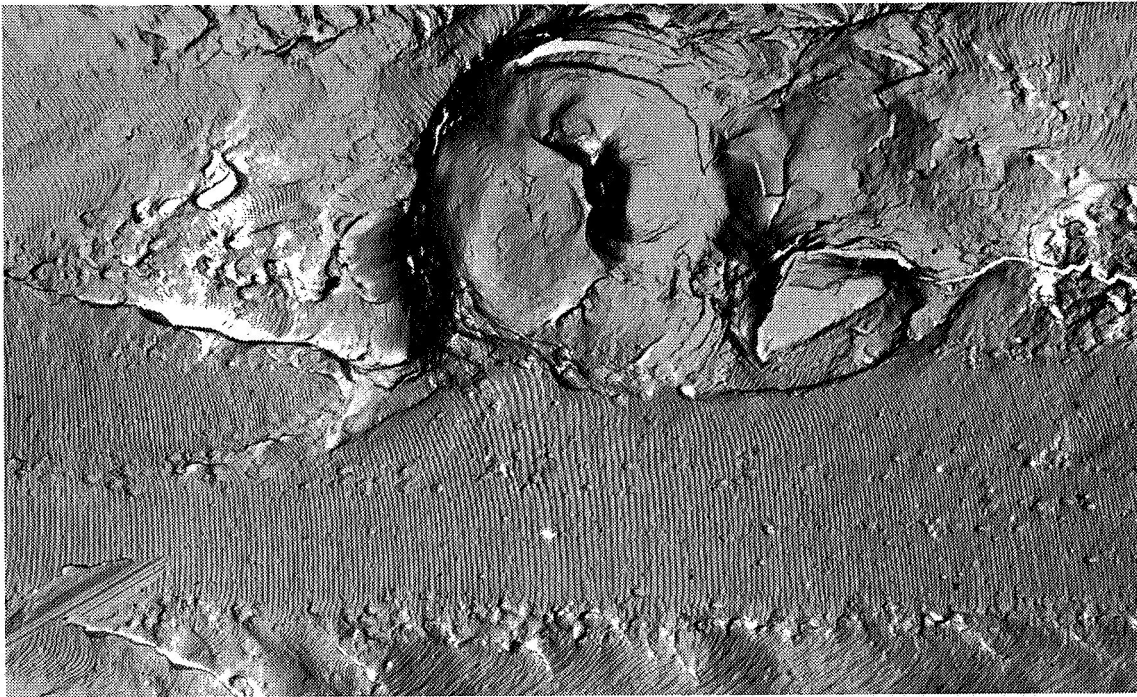
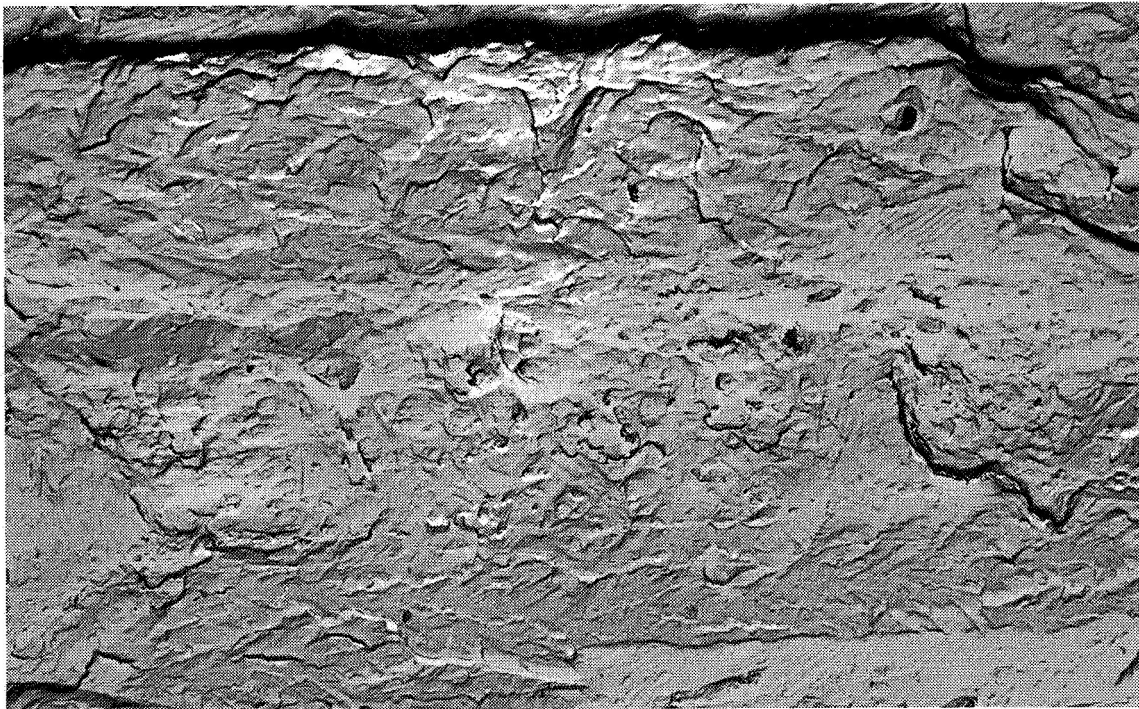
Figure 23. *Electron fractographic comparison of the fatigue-fracture mode for the 0.25-inch-thick underaged material at $2a = 2.00$ inches (Magnification 3200X)*

Comparing figures 23a, 24a, and 25a (dry-air test environment), it is apparent that the prevailing crack-propagation mechanism is a ductile striation formation for all three aging conditions. It is also apparent that the striation spacing is smaller on the overaged specimen. By contrast, figures 23b and 24b (distilled-water environment) show examples of more brittle fractures, which are commonly termed brittle striations. These brittle striations often occur in 7000-series aluminum alloys when growth rates are accelerated by environmental effects. In the overaged condition, figure 25b, the specimen tested in the wet environment does not show the brittle striations, and only ductile striations are present. An additional comparison for peak-aged and overaged conditions is shown in figures 26 and 27 for the 0.63-inch material tested under both environmental conditions. The test results showed that the overaged specimens tested in the dry-air and distilled-water environments had slower growth rates than comparative specimens in the underaged or T6 conditions. It is also apparent that fatigue-crack-growth rates are noticeably increased in the aqueous environment for all three heat-treatment conditions. However, the wet-environment growth rate for the overaged material is approximately the same as dry-environment growth rates for the underaged and T6 conditions.

Conclusions: Both the underaged and peak-aged materials show a strong effect of a wet environment on crack growth rate evidenced by a change in fracture mode from ductile to brittle striations. The overaged material shows less environmental effect, and the fracture mode is predominantly ductile striation formation in both environments. The effect of reducing the R value of 0.67 to 0.05 is to increase the cracking rate as indicated by larger striation spacings for the same crack length and the earlier onset of ductile tearing modes. The low-temperature environment also changes the fracture appearance as compared to the dry-air case in that the striations are not well developed. This may be the result of differences in the surface oxide characteristics.

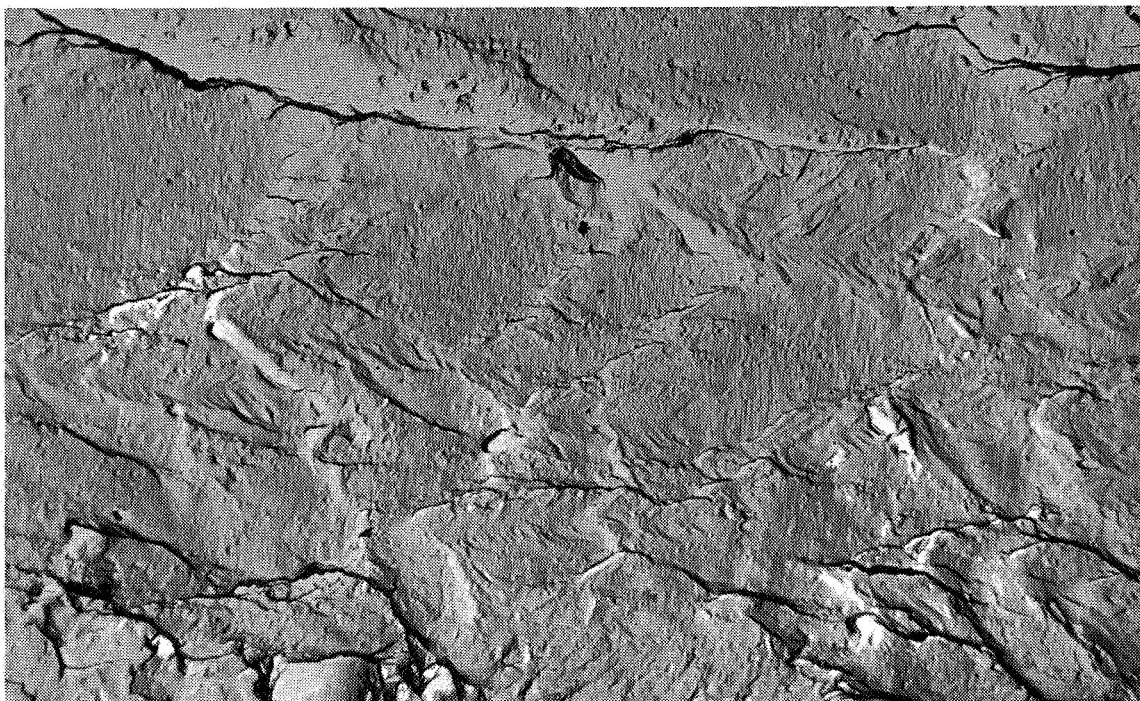
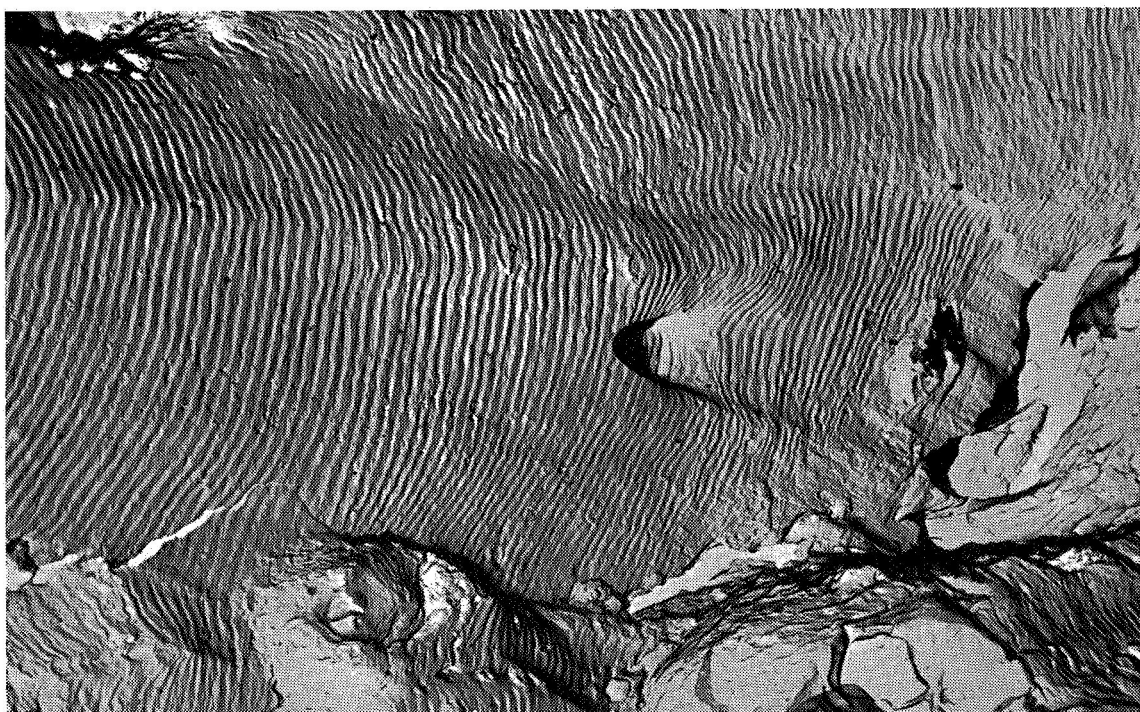
Figure 28. Electron fractographic comparison of 0.25-inch-thick underaged material tested at two stress ratios in a dry-air environment, $2a = 1.2$ inches (Magnification 3200X)

A change in R value ($R = 0.67$ to $R = 0.05$) for the dry-air condition changed the fracture appearance only by changes in striation spacing for the same crack length and an earlier onset of ductile tearing when $R = 0.05$. The striation spacings for the two R values at the same crack length are compared in figure 28a and b.

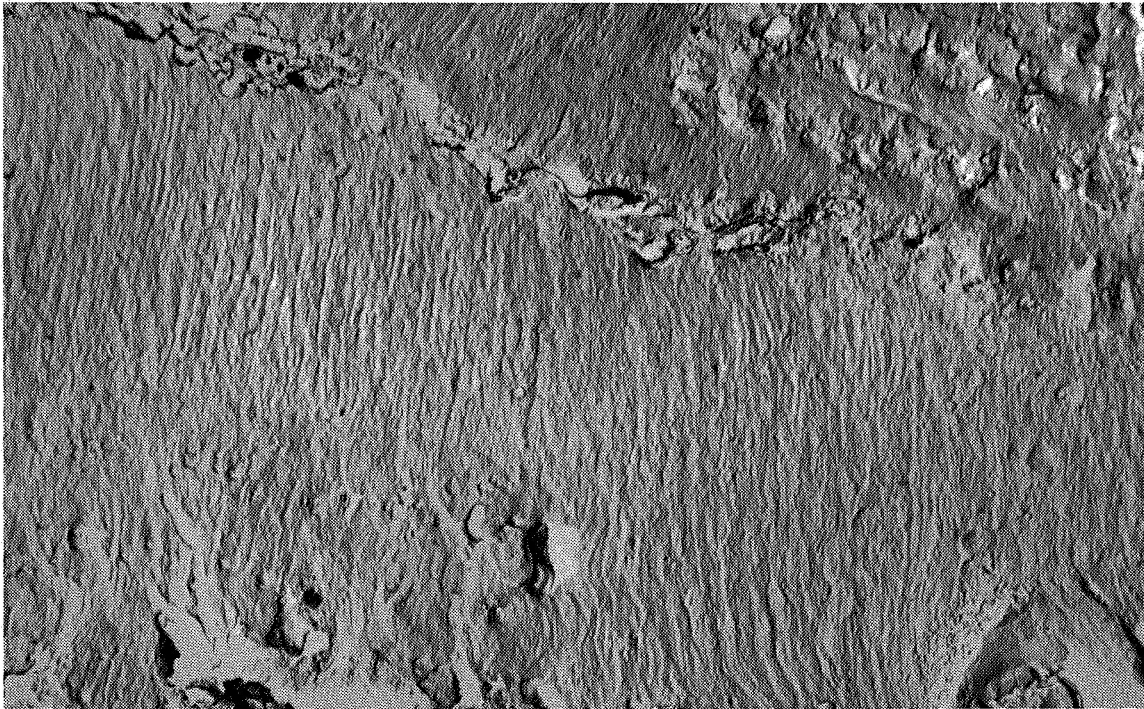
Figure 29. Electron fractographic example of 0.25-inch-thick underaged material tested at -65°F ; $R = 0.05$, $2a = 1.2$ inches (Magnification 3200X)

Testing at -65°F slowed the fatigue-crack-growth rates slightly. The striations were generally ill defined for specimens tested at this low temperature, figure 29. This observation was general for all heat-treat conditions. The reason for this behavior is not clearly understood, but may be related to the formation of a surface oxide during test. An analogous situation occurs when testing in vacuum where no striations are observed under high-vacuum conditions, but well-defined striations may be observed as atmospheric pressures are approached.

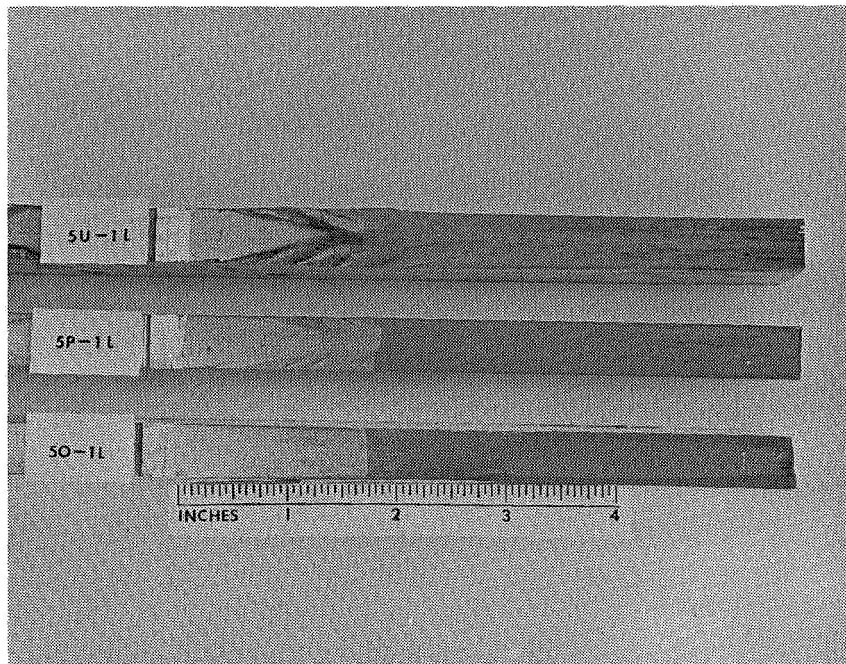
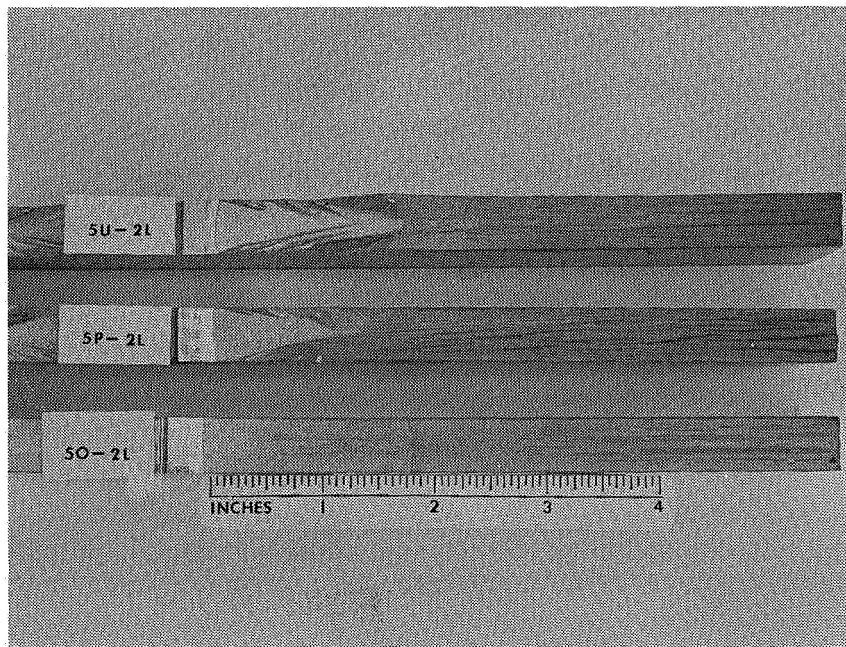
Figure 30. Macroscopic view 0.50-inch-thick center-notched panels tested at room temperature in dry air, and at -65°F

Results: The fractured specimens are shown in figure 30. The -1L specimens were fracture tested at room temperature while the -2L series was tested at -65°F. Delamination or transverse splitting was particularly pronounced on the underaged and peak-aged specimens. Low temperatures accentuated this feature and the overaged specimen also experienced transverse splitting. The delamination is most extensive at the ends and decreases toward the centers of the specimens. The extent of the delaminations at the ends of the specimens is shown in figure 31. Sections through the material show this cracking to be intergranular in nature. For comparison, sections taken 1 inch from the end of the overaged specimen tested at room temperature and underaged specimen tested at -65°F are shown in figure 32.

Conclusions: These short transverse delaminations are intergranular indicating that the material cannot sustain high stresses in the short transverse direction without cracking along grain boundaries. The tendency toward delamination is enhanced by testing at low temperatures. Overaging reduces the tendency of the material to delaminate.

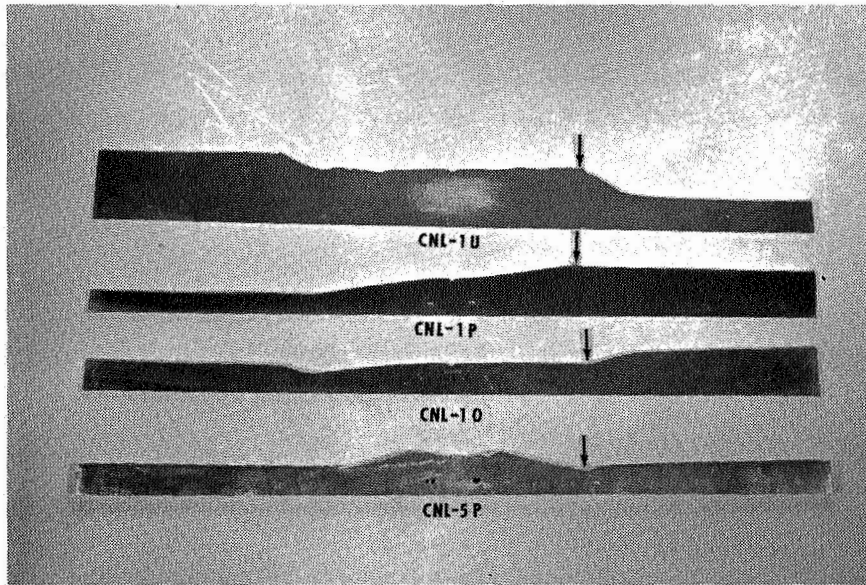
Figure 33. Macroscopic fracture profiles of center-notched 36-inch-wide panels (Magnification approximately 1/10X)

Results: Fracture profiles for these specimens are shown in figure 33. The only unusual feature apparent on these specimens is that the initial crack propagation from the end of the fatigue crack was inclined 45° to 60° with respect to the tensile axis for specimens CNL-1U and CNL-1O. By contrast, initial crack propagation on specimen CNL-1P was essentially normal to the tensile axis as would be expected. The growth of the crack out of the normal fracture plane will tend to result in higher calculated toughness values. No metallurgical reason for growth out of the plane was apparent.

Conclusions: The high-toughness values were apparently due to crack deviation from the plane normal to the tensile axis.

Results: Profiles of the fractures are shown in figure 33. An examination of the fracture surface at six crack lengths verified the marked difference in crack propagation rates as indicated by the striation spacing. Typical fractographic examples showing the relative spacing are presented in figure 34. No metallurgical variation that could account for the effect was observed.

NOTE: Arrows indicate the extent of the fatigue zone
